BELCHER STREET MARSH MANAGED REALIGNMENT RESTORED 2018

BELCHER STREET MARSH MANAGED DYKE REALIGNMENT AND TIDAL WETLAND RESTORATION SITE

The Belcher Street Marsh is located on the Jijuktu'kwejk/Cornwallis River in Kentville. The site was realigned and restored in December 2018 to address erosion and loss of foreshore marsh, reduce flood risk to nearby towns, and increase resiliency of the system.

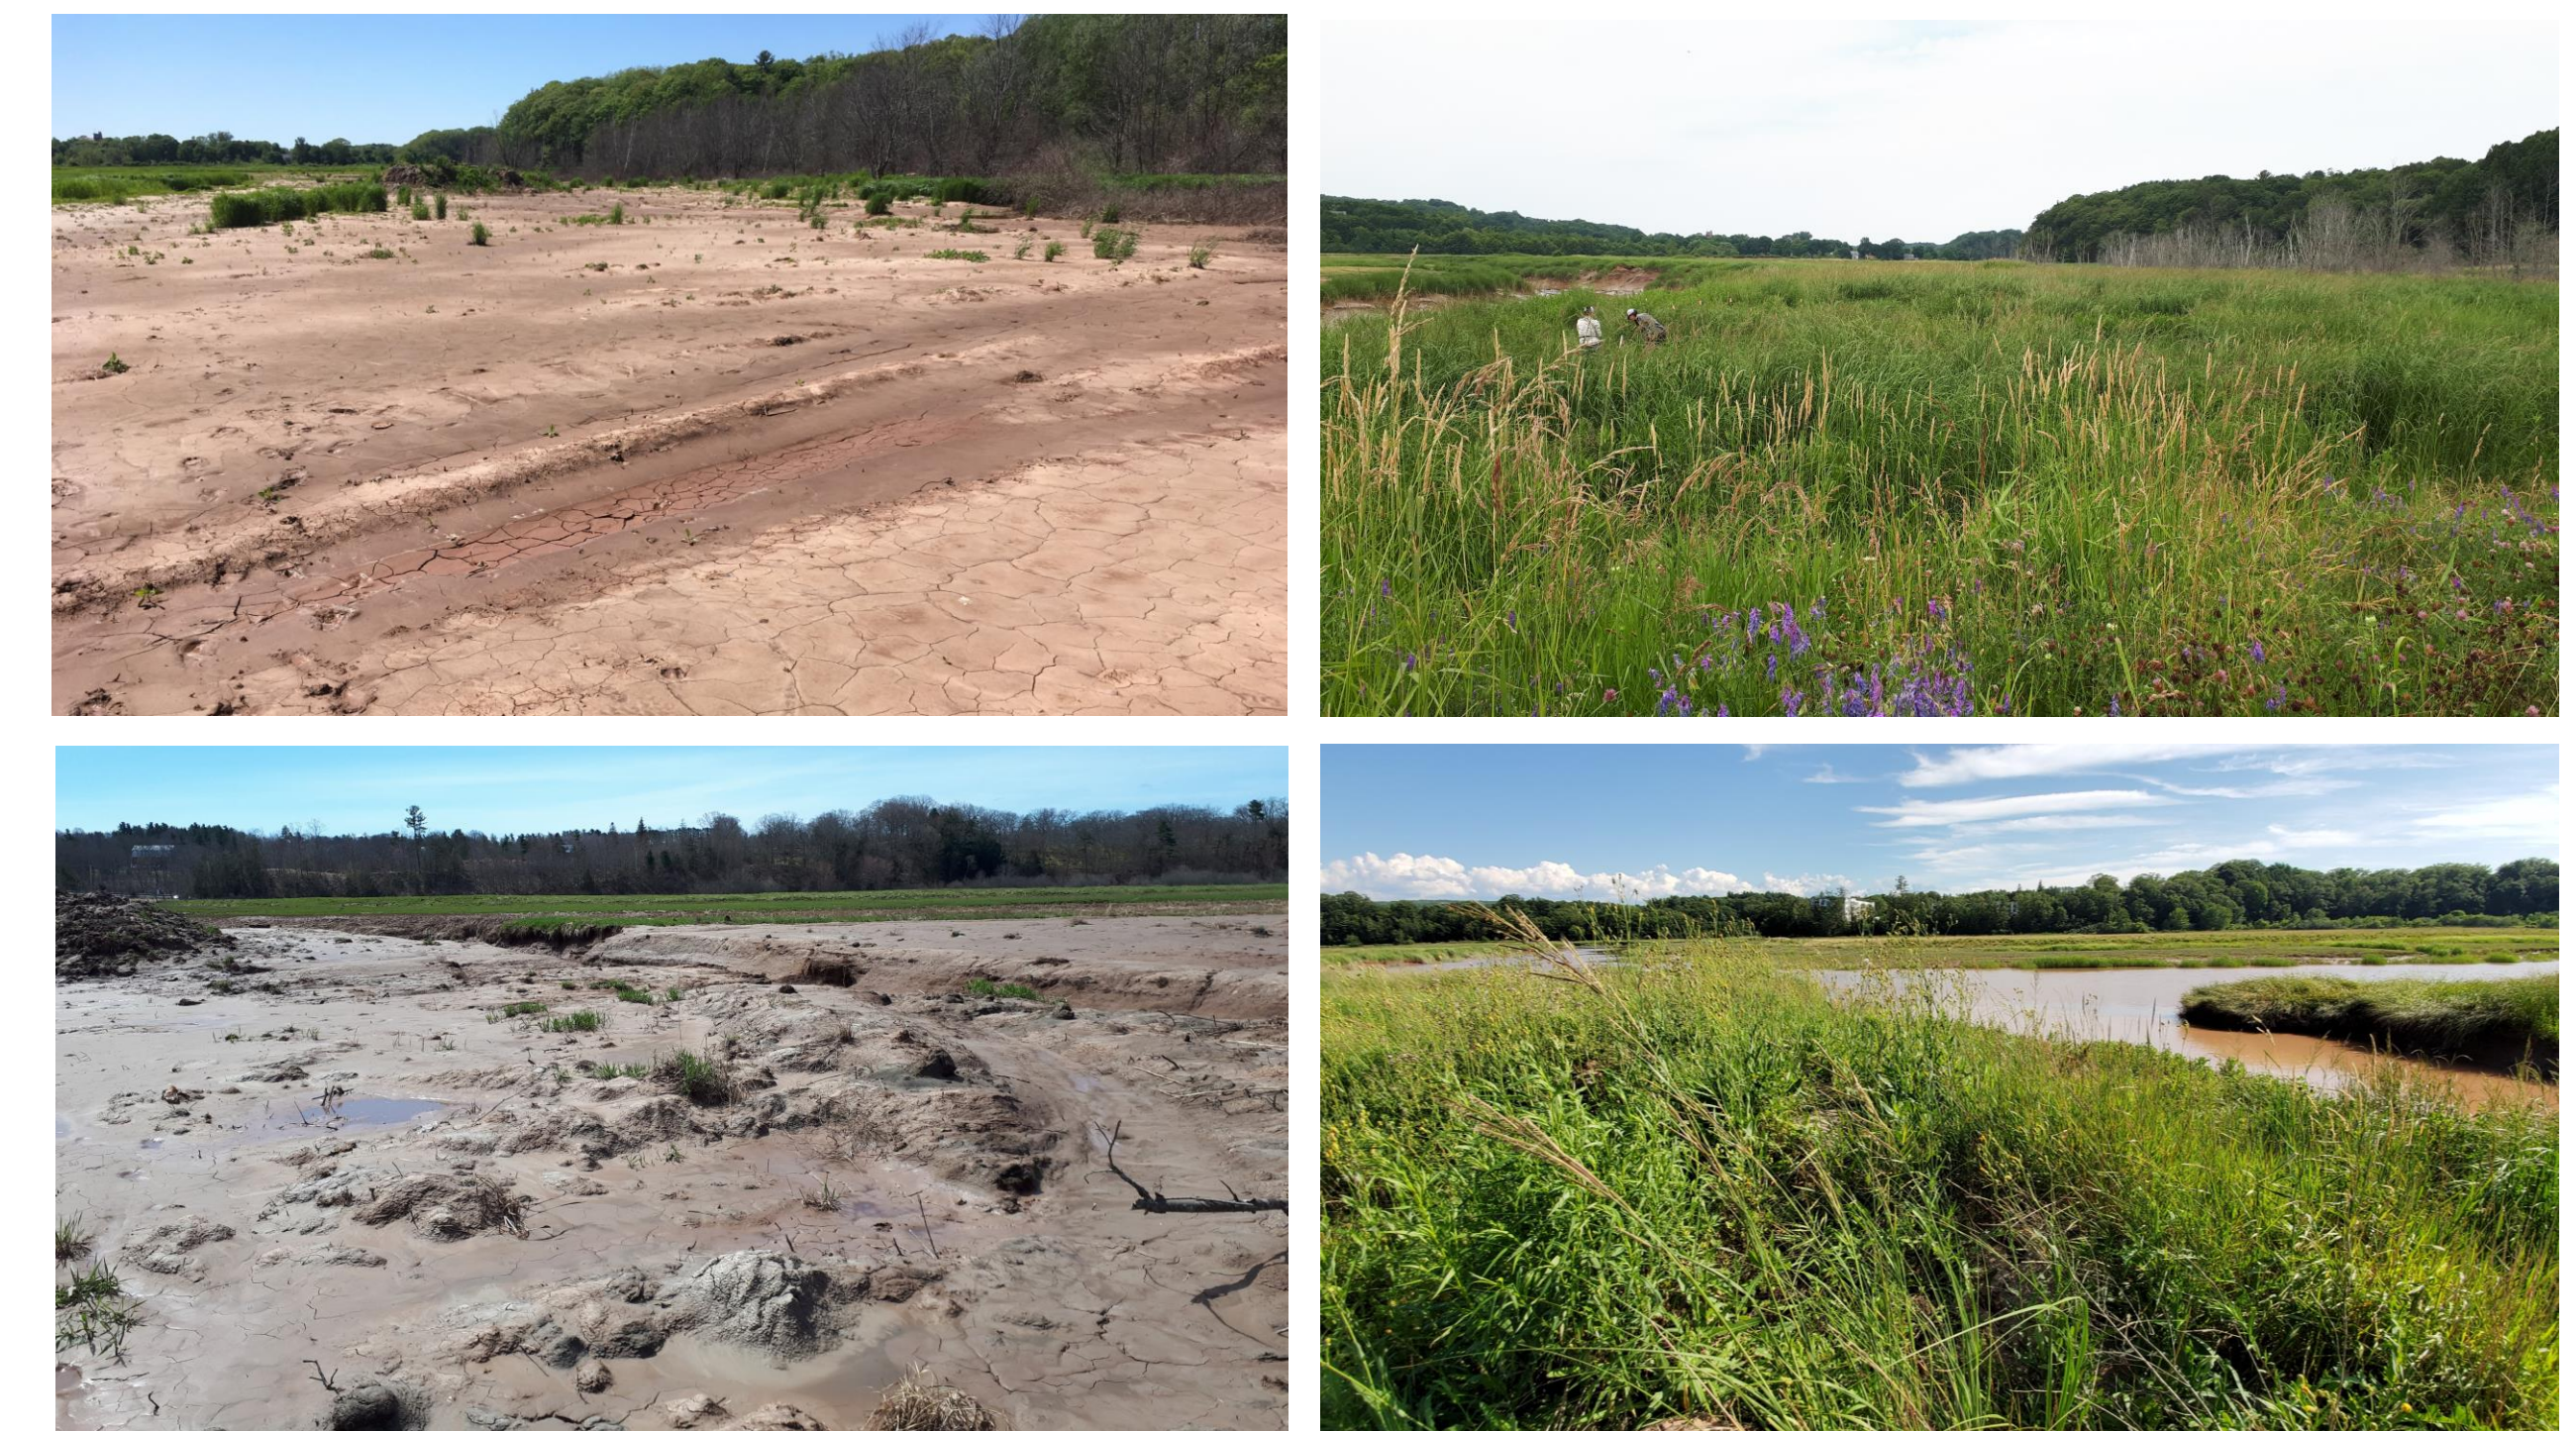
The Belcher Street site went from being a mudflat in 2018 to only having 17% bare ground in Year 2 of restoration (2019). By Year 4 (2021), there was nearly 0% bare ground.

Top: Belcher Marsh platform (left) Year 2 post restoration, June 2019; (right) Belcher Marsh in Year 4 post restoration, July 2021. Bottom: Constructed tidal channel and vegetation (left) Year 2, April 2019; (right) Year 3, July 2020 (CBWES Inc).

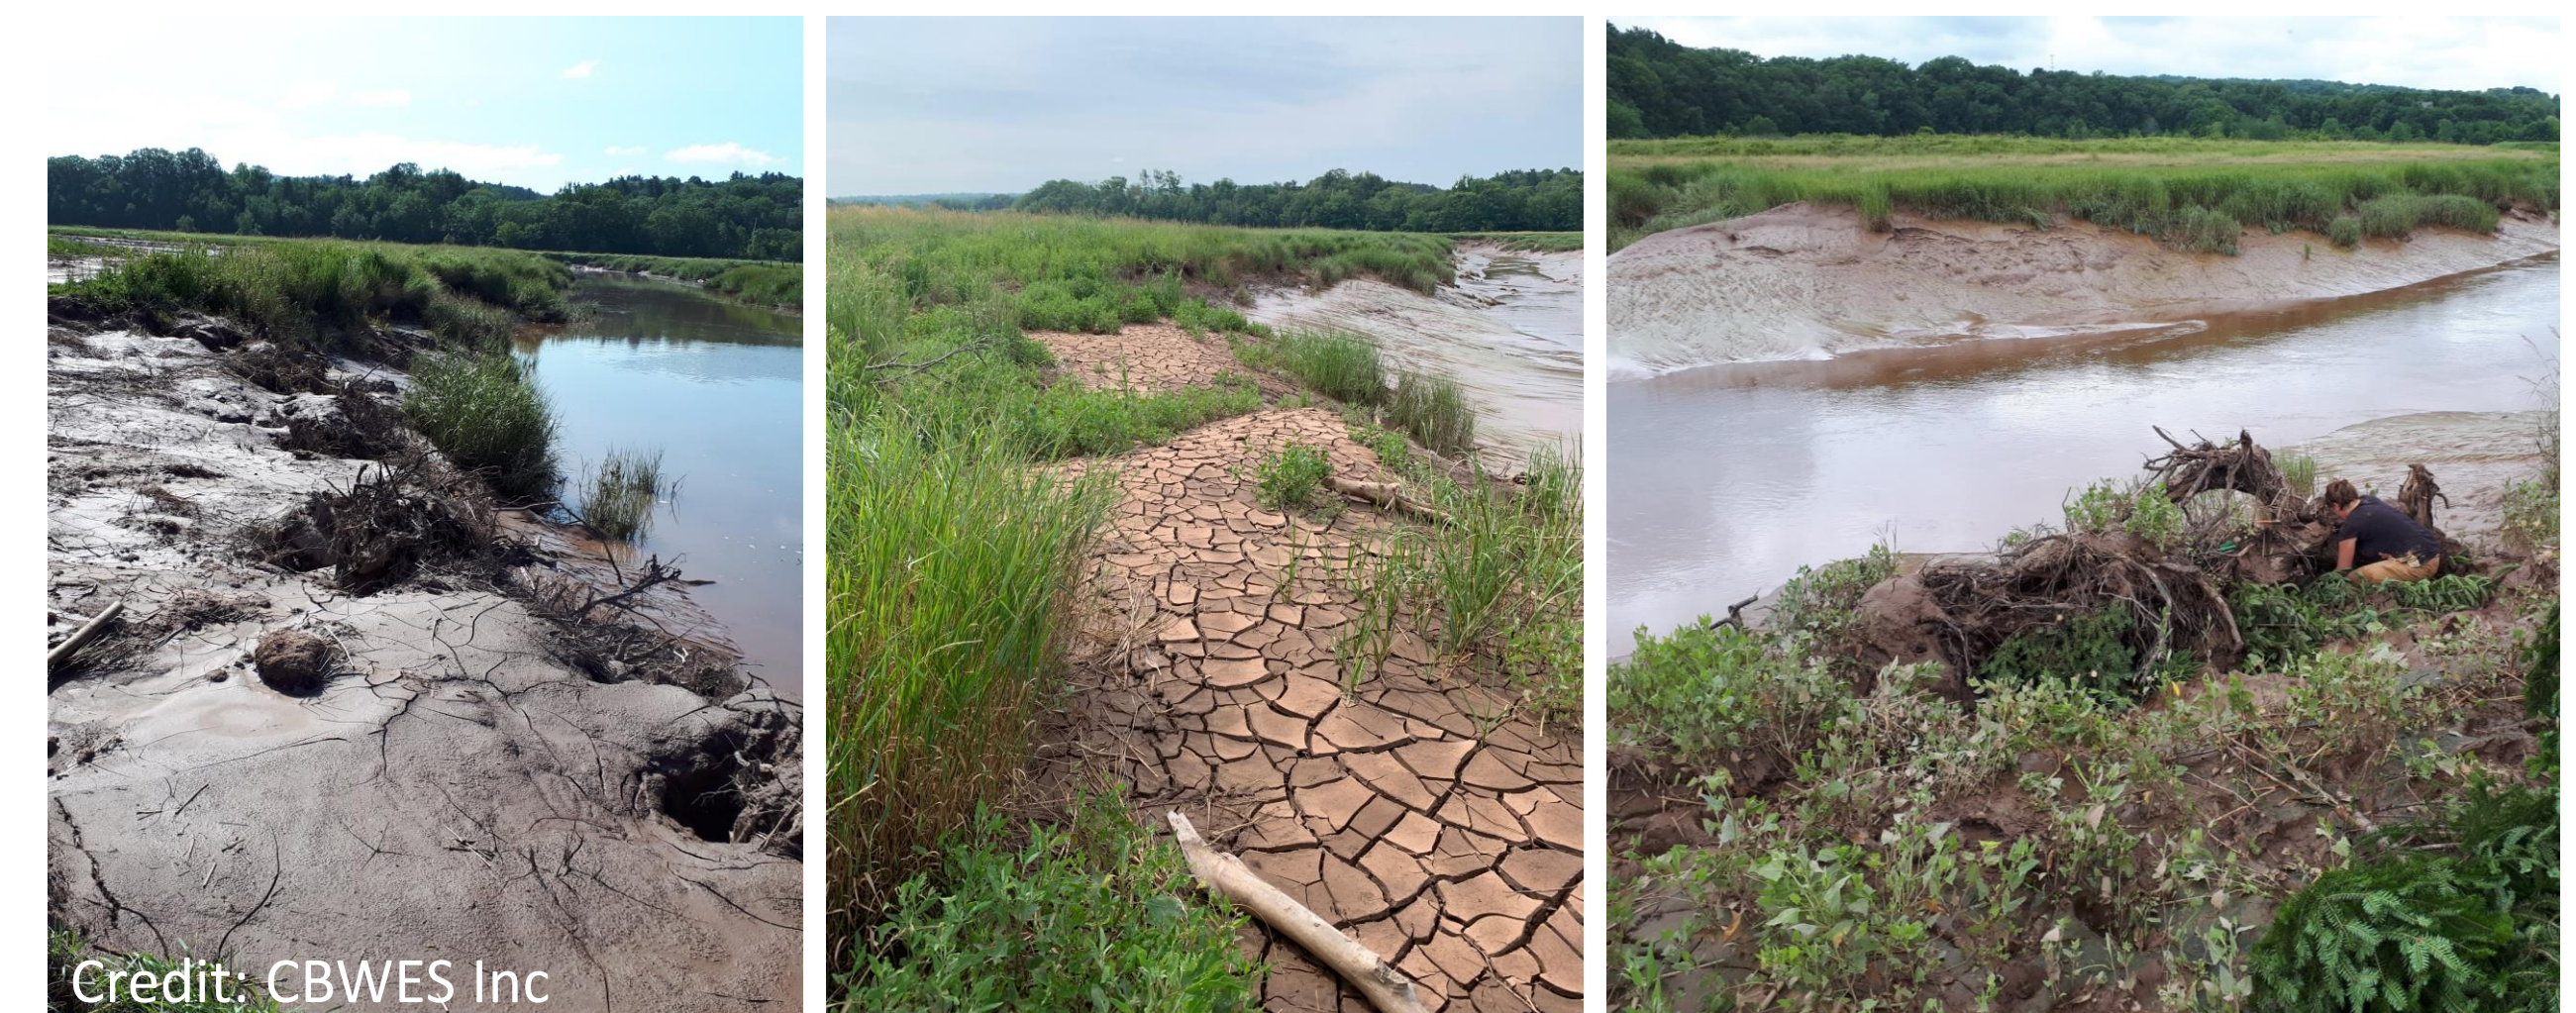
A hybrid living shoreline was installed at the Belcher Street Marsh to curtail erosion on a stretch of riverbank.

The living shoreline (left) November 2018 with visible root wads; (middle) July 2021 after adaptive management; (right) July 2019 adding evergreen trees to fill holes in root wads, in addition to adding silt and wattle fencing and planting native vegetation.

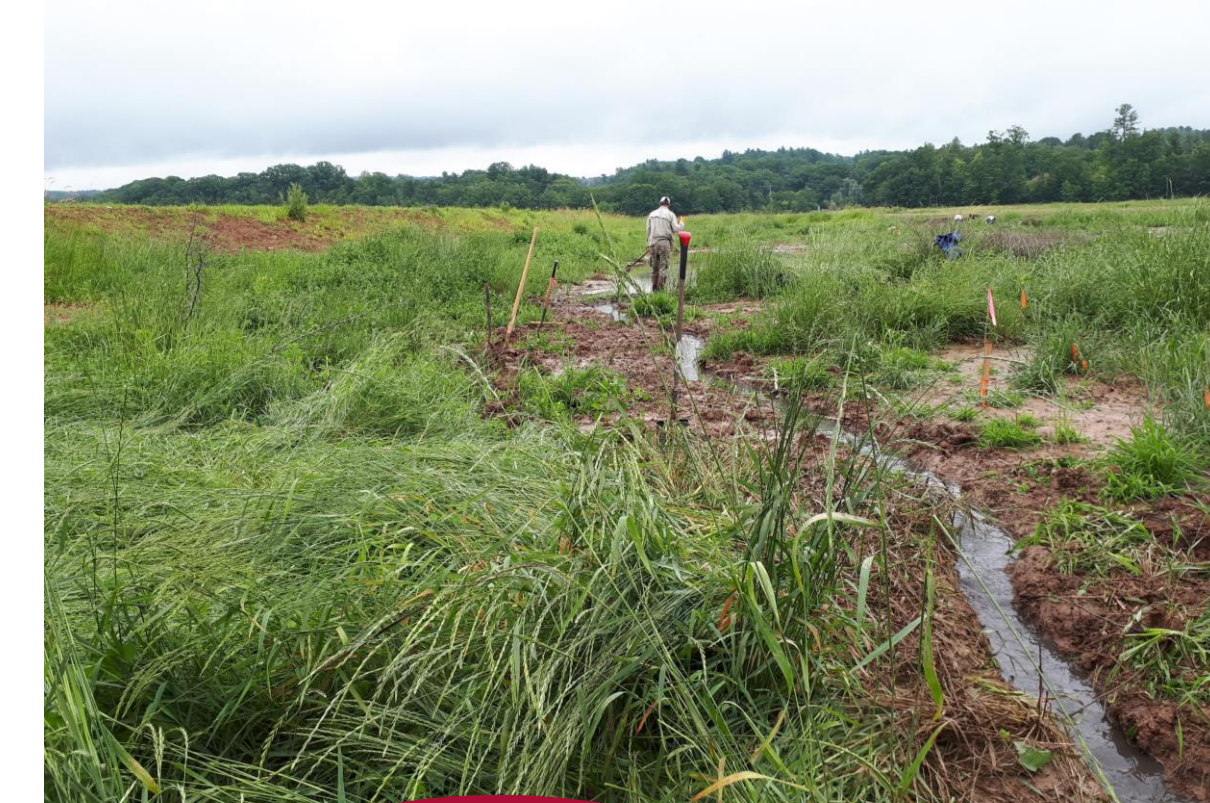
To address ponding water, a runnel was dug to connect to the larger drainage network.

Hand digging a channel, July 2019 (CBWES Inc).
