MANAGED DYKE REALIGNMENT (MR) AND TIDAL WETLAND RESTORATION

THE PROCESS OF MANAGED DYKE REALIGNMENT

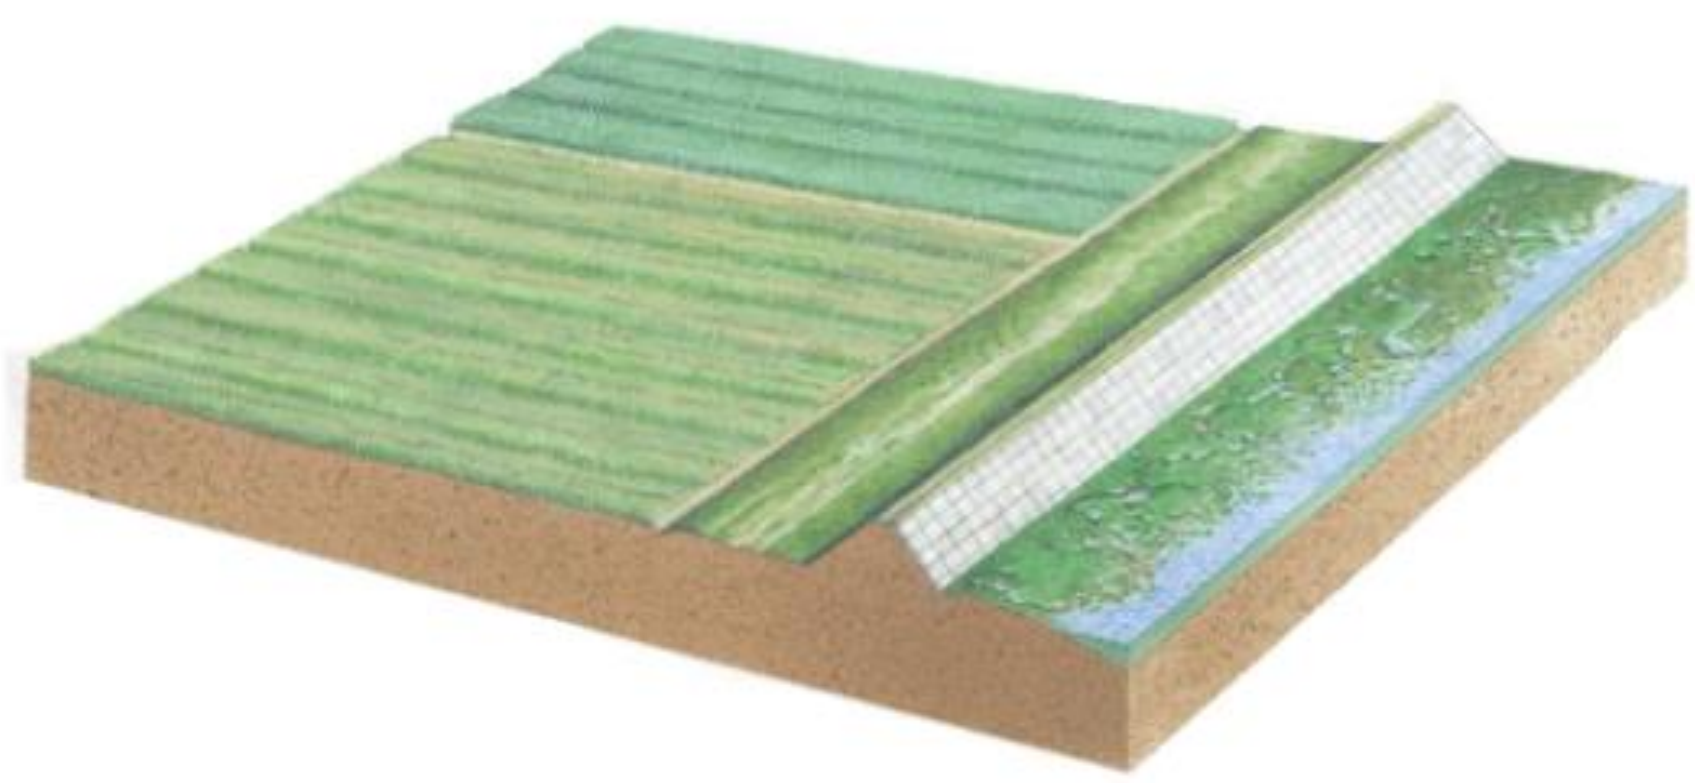
Existing 'hard' flood defences.

If no high ground is present inland a new flood bank is built behind the existing one. The land between the two defences is contoured to ensure the right habitat is created.

The old defence is breached allowing the tide to move in and out.

As the tide moves in and out, mud is deposited and intertidal habitat is created between the banks. This soaks up wave energy.

a) Existing agriculture dyke b) A new dyke is built c) The old dyke is breached d) Tides deposit sediment and a new tidal wetland is established (source: <http://worldlywise.pbworks.com/w/page/15409213/Unit%201%20Section%20B%20-%20Managing%20coastal%20areas>).

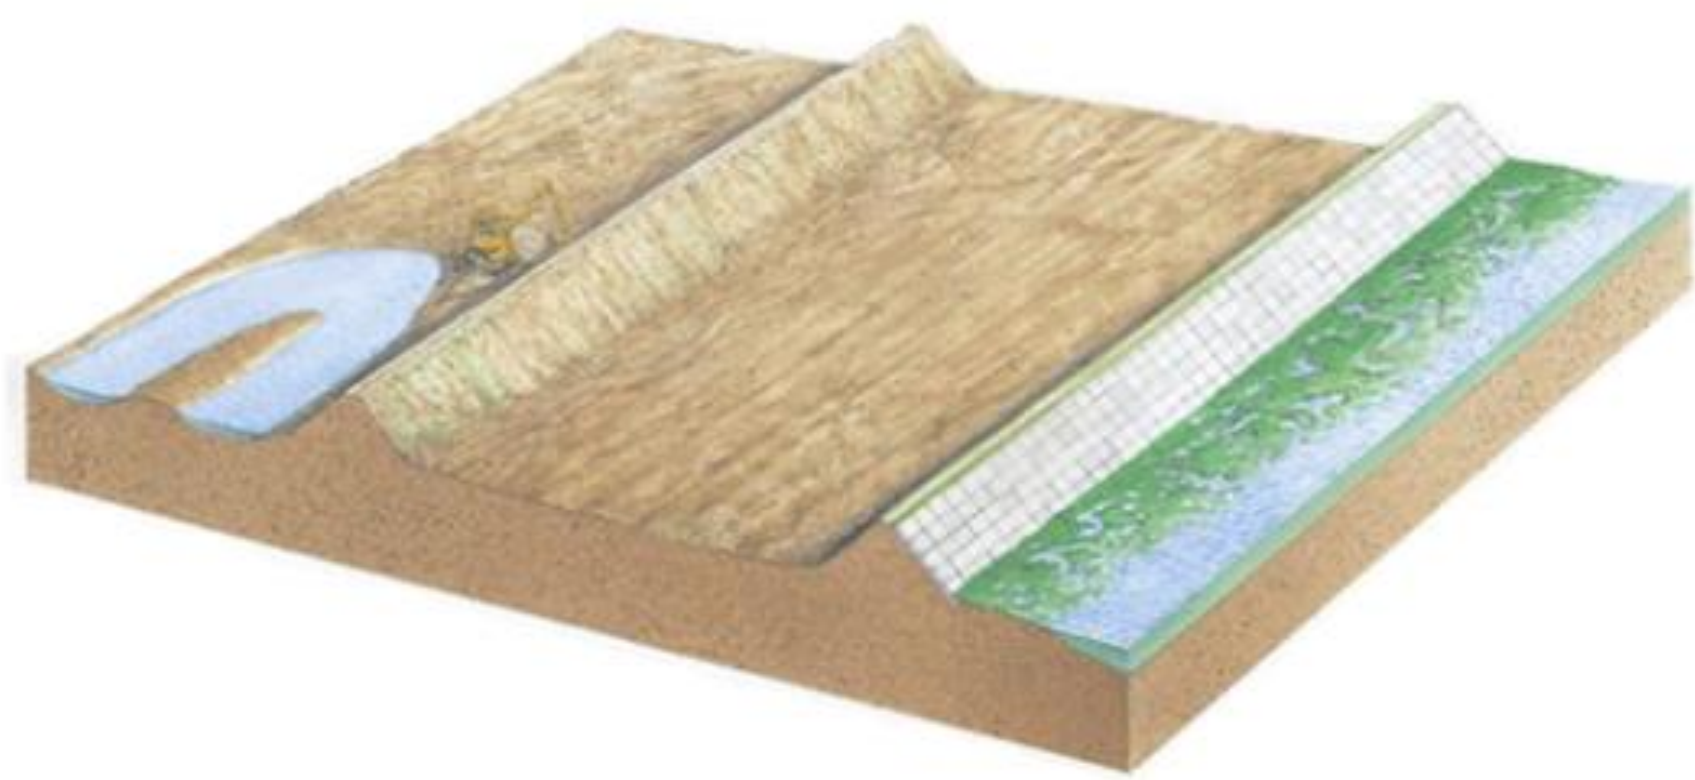
Existing 'hard' flood defences.

If no high ground is present inland a new flood bank is built behind the existing one. The land between the two defences is contoured to ensure the right habitat is created.

The old defence is breached allowing the tide to move in and out.

As the tide moves in and out, mud is deposited and intertidal habitat is created between the banks. This soaks up wave energy.

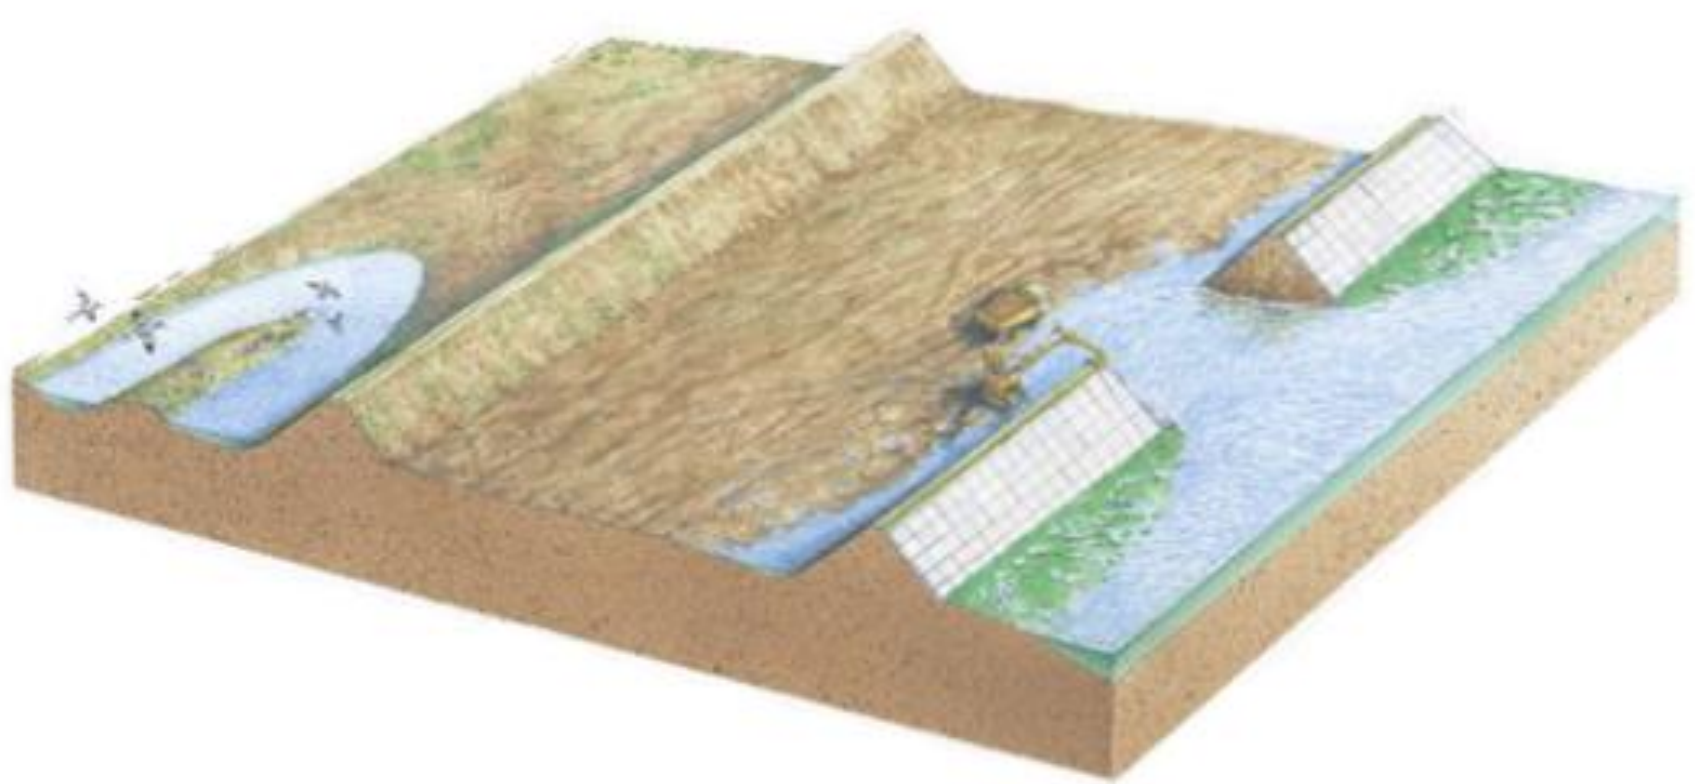
Existing 'hard' flood defences.

If no high ground is present inland, a new flood bank is built behind the existing one. The land between the two defences is contoured to ensure the right habitat is created.

The old defence is breached allowing the tide to move in and out.

As the tide moves in and out, mud is deposited and intertidal habitat is created between the banks. This soaks up wave energy.

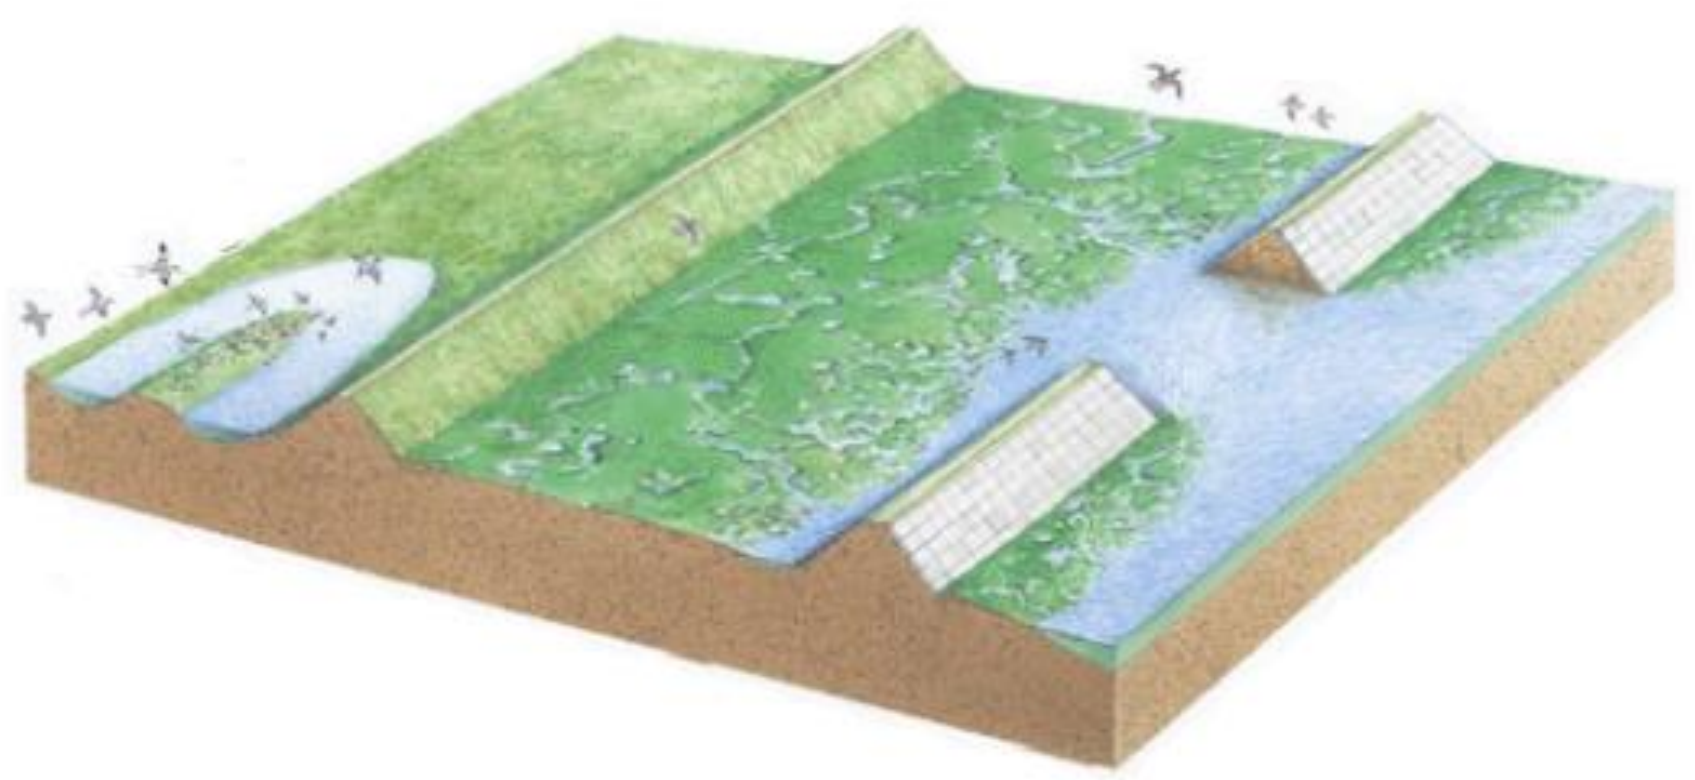
Existing 'hard' flood defences.

If no high ground is present inland, a new flood bank is built behind the existing one. The land between the two defences is contoured to ensure the right habitat is created.

The old defence is breached allowing the tide to move in and out.

As the tide moves in and out, mud is deposited and intertidal habitat is created between the banks. This soaks up wave energy.

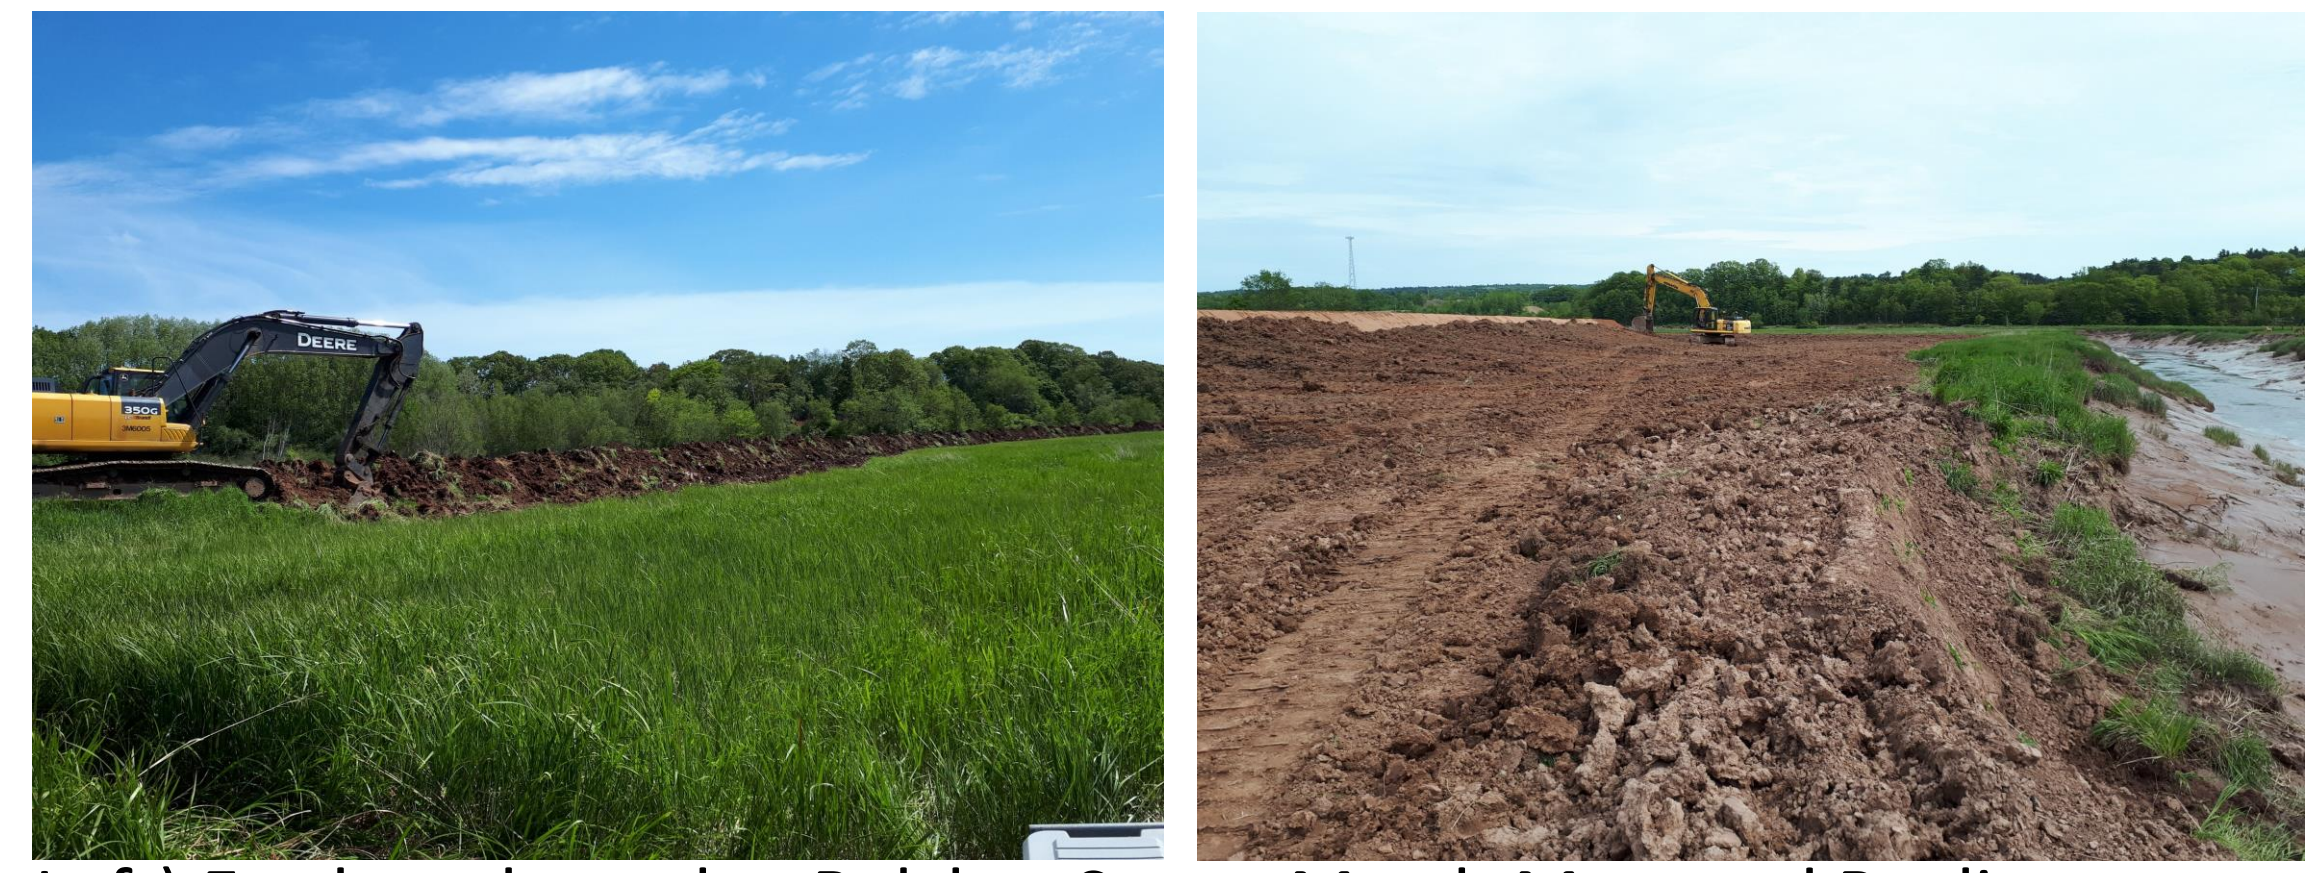
Left) Earthworks at the Belcher Street Marsh Managed Realignment Site, Right restored 2018, CBWES Inc.

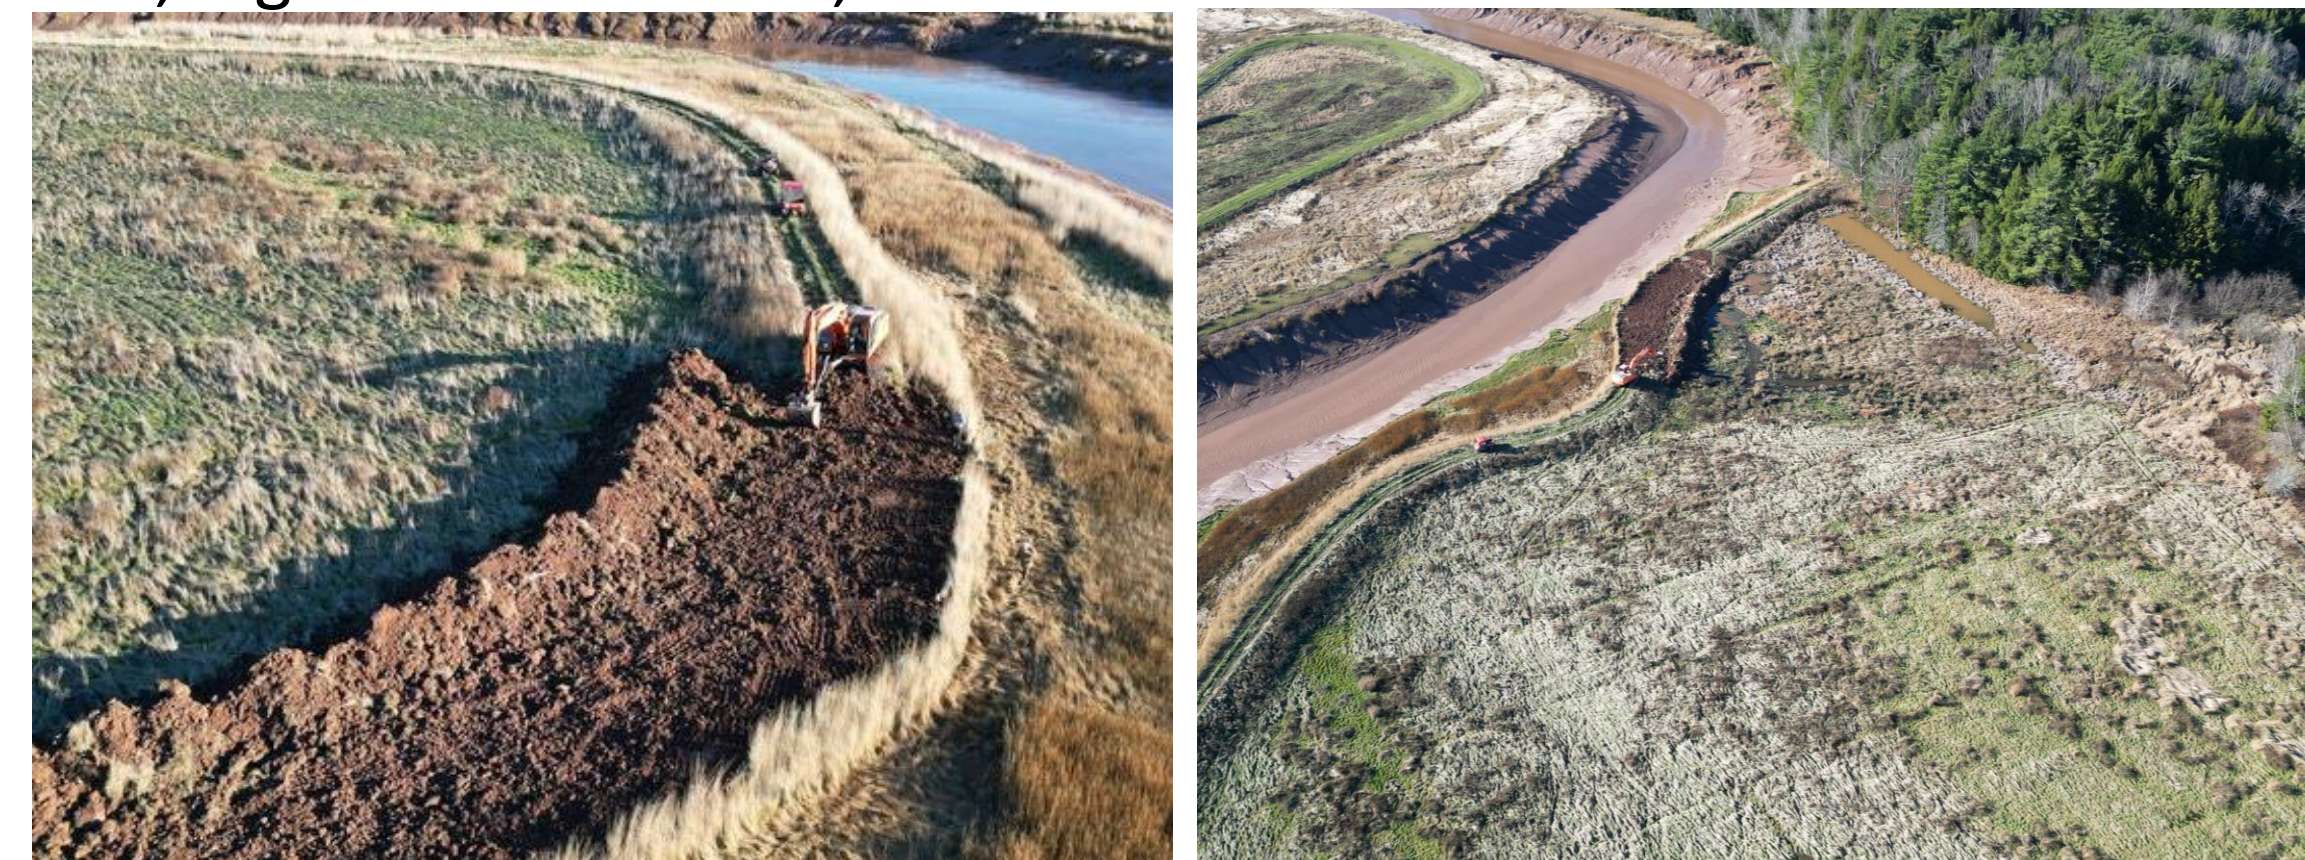
Earthworks at the Ksu'ksw Mqoqt/Hemlock Marsh Managed Realignment Site, restored 2022, CBWES Inc.

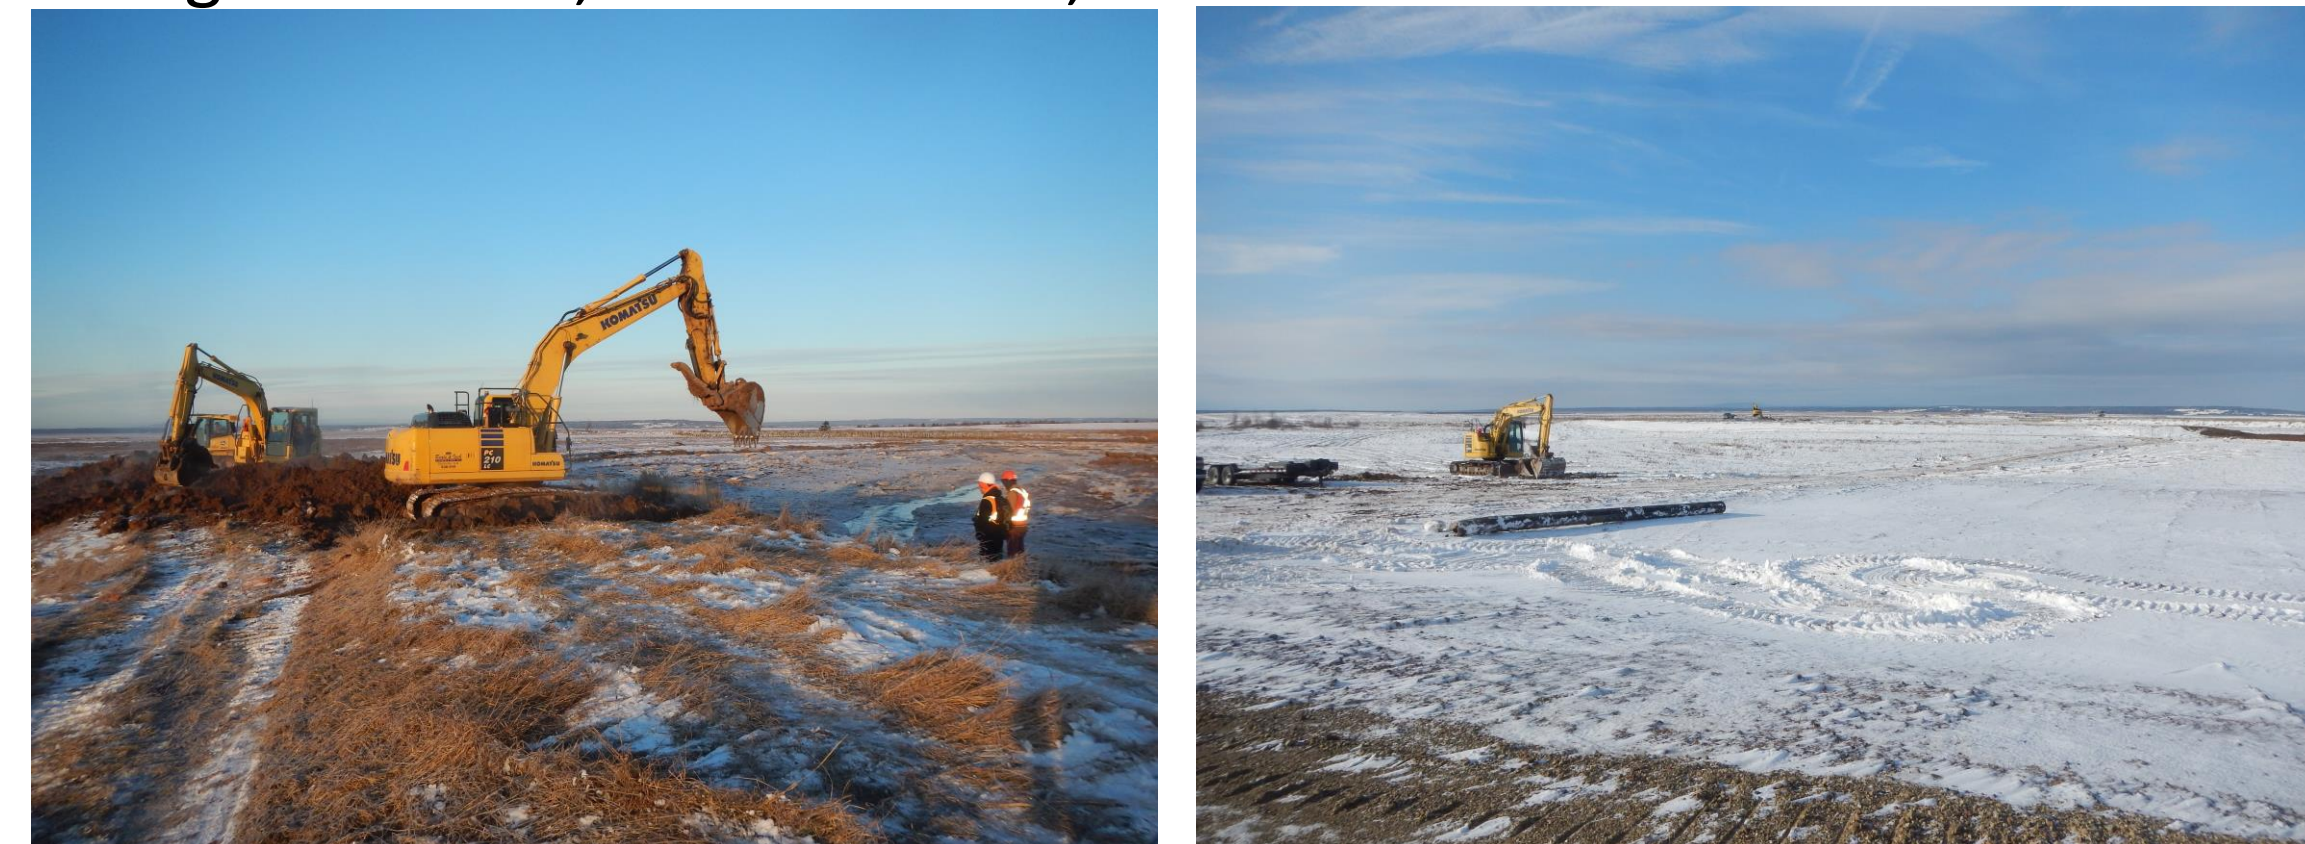
Earthworks at the Converse Marsh Managed Realignment Site, restored 2019, CBWES Inc.
